1. INTRODUCTION

This Inspection Report includes findings and observations concerning the National Pollutant Discharge Elimination System (“NPDES”) Stormwater Inspection (“Inspection”) conducted by José A. Rivera, Lead Environmental Engineer, Clean Water Act Team (the “EPA Inspector”), of the United States Environmental Protection Agency’s (“EPA”) Caribbean Environmental Protection Division (“CEPD”) at the Aguadilla Pier, Corp. (“Aguadilla Pier” or “APC”) property located in Aguadilla, Puerto Rico (the “Site” or “Property”). **Image 1** (below) depicts an aerial imagery of the Site found in Google Earth Pro™, with imagery dated June 11, 2017.

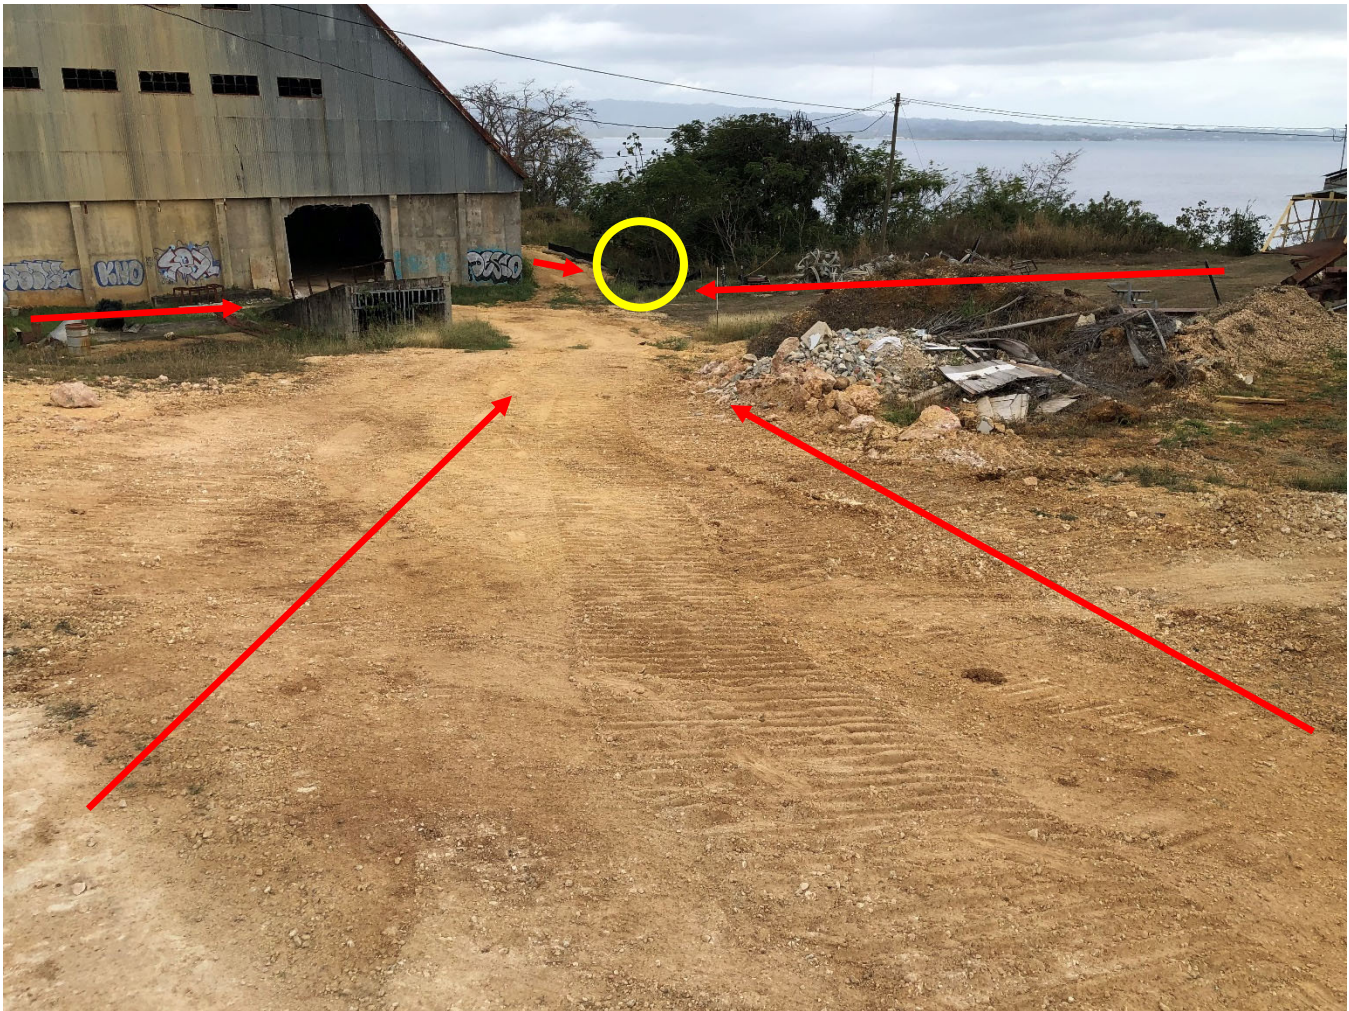
Picture 14
(Iphone 8+ Camara: IMG_5651.JPG; 2/23/23; 10:57 a.m.)

- ✚ This picture depicts the north side of the Warehouse Building and areas nearby.
- ✚ The yellow-colored circle depicts the approximate location of Outfall 001. The red arrows depict the approximate storm water runoff path towards Outfall 001.
- ✚ Access road to the Warehouse Building and surrounding areas depicted lacked soil stabilization, erosion controls and storm water runoff management.
- ✚ Two small soil piles without erosion controls. One of the soil piles also observed with construction debris and lacking erosion controls. Fresh heavy equipment tracks also shown.

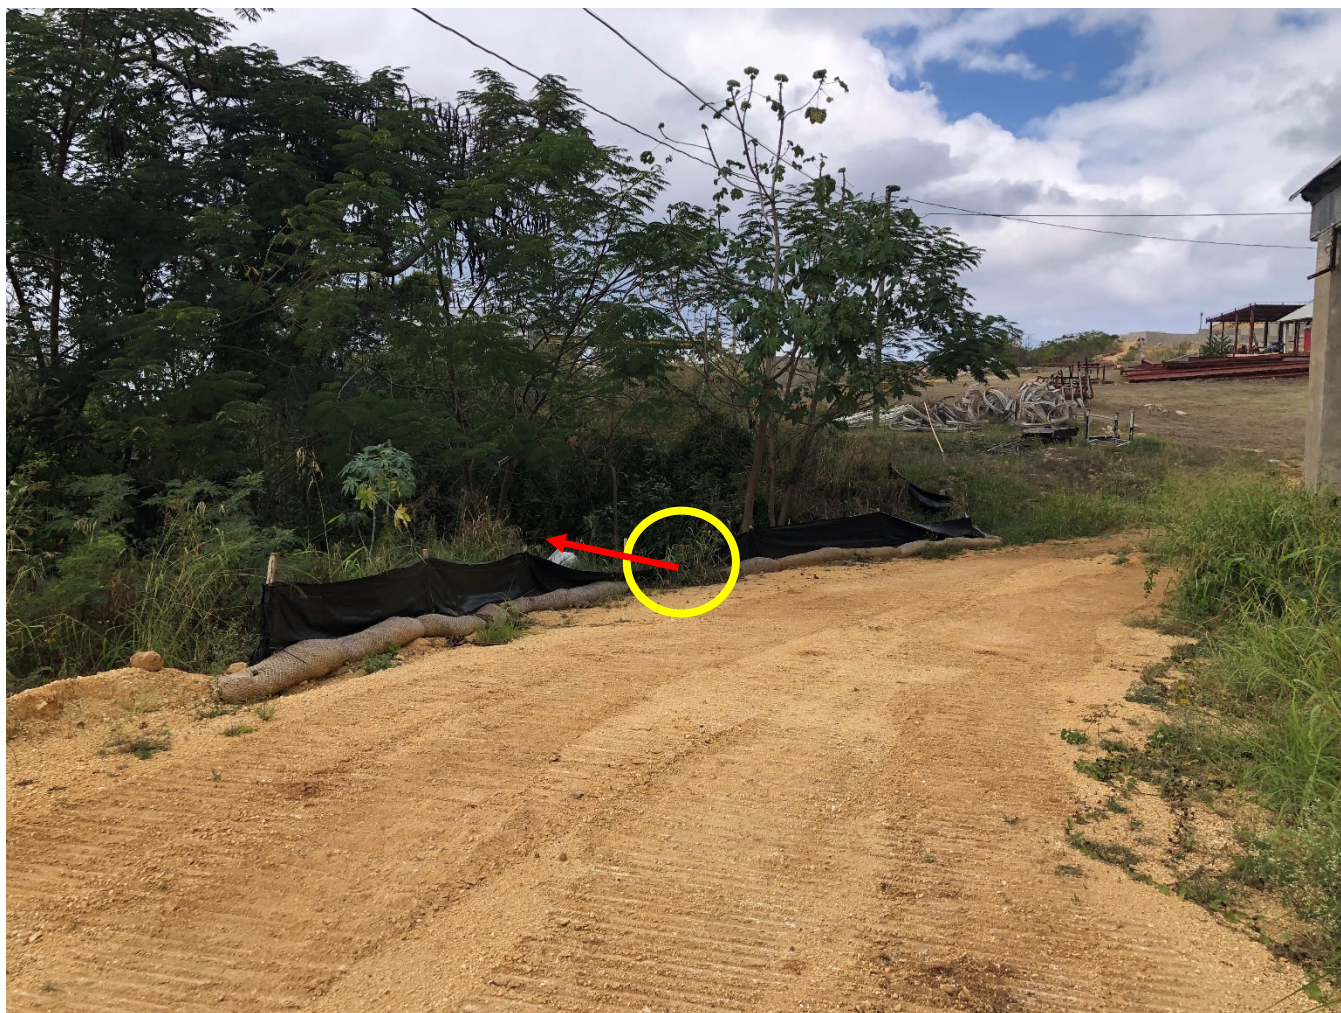
Picture 15

- ✚ This picture depicts the approximate location of Outfall 001 (yellow-colored circle) located on northwest area of the Warehouse Building. This picture also depicts another view of the areas north of the Warehouse Building.
- ✚ The red arrow depict approximate storm water runoff path from Outfall 001 towards the receiving water.
- ✚ Access road to the Warehouse Building and surrounding areas depicted lacked soil stabilization, erosion controls and storm water runoff management.
- ✚ The silt fence and logs were deteriorated, and fresh heavy equipment tracks also shown.

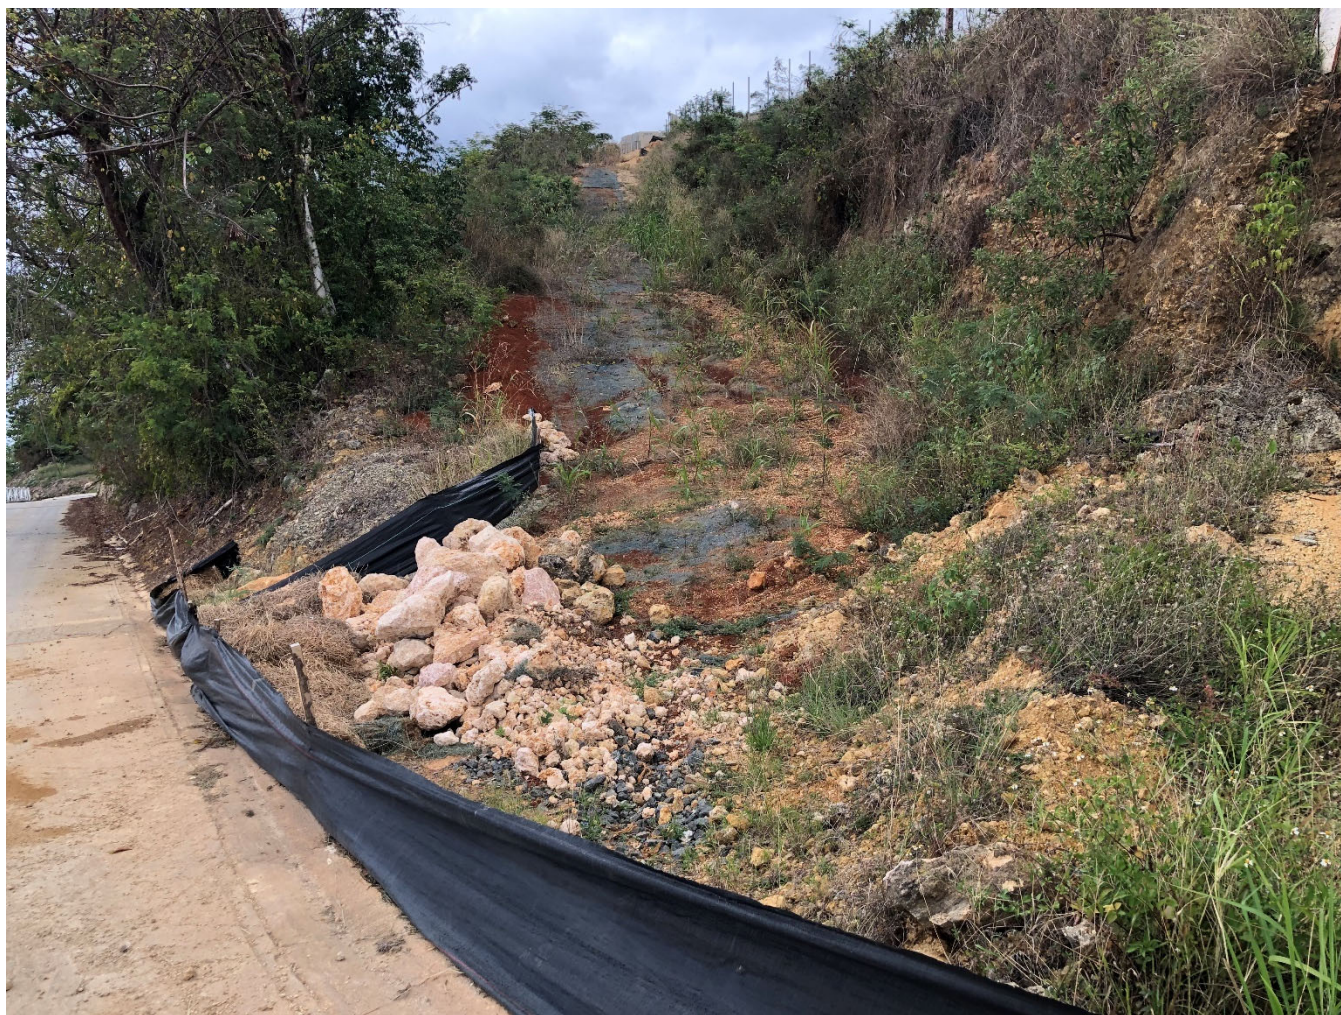
Picture 16

- ✚ This access road on the west side was blocked with boulders. The erosion controls (i.e., silt fence and what appears to be hay bales) are deteriorated.
- ✚ Areas of this dirt road remains without final soil stabilization, which are mostly found on the upper side of the slope.
- ✚ This picture also depicts the concrete road to the lower areas of the Site on the west boundary, where two structures were constructed and later demolished.

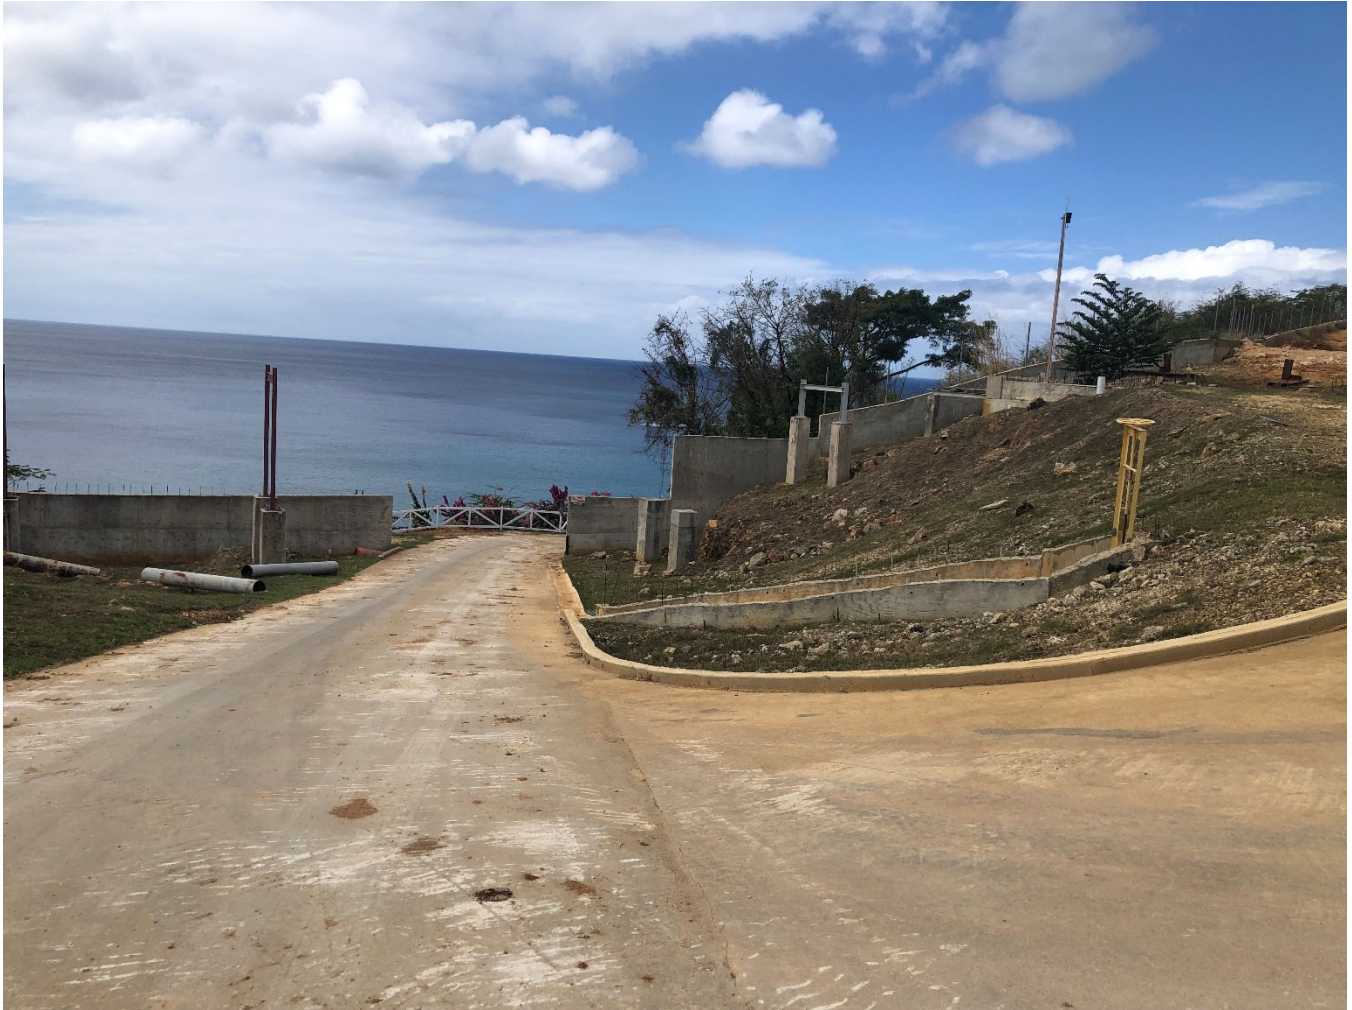
Picture 17
(Iphone 8+ Camara: IMG_5667.JPG; 2/23/23; 11:19 a.m.)

- ✚ Picture depicts concrete road to the lower areas of the Site on the west boundary, where two structures were constructed, and demolished.
- ✚ Sediment track out marks on the concrete pavement also shown.

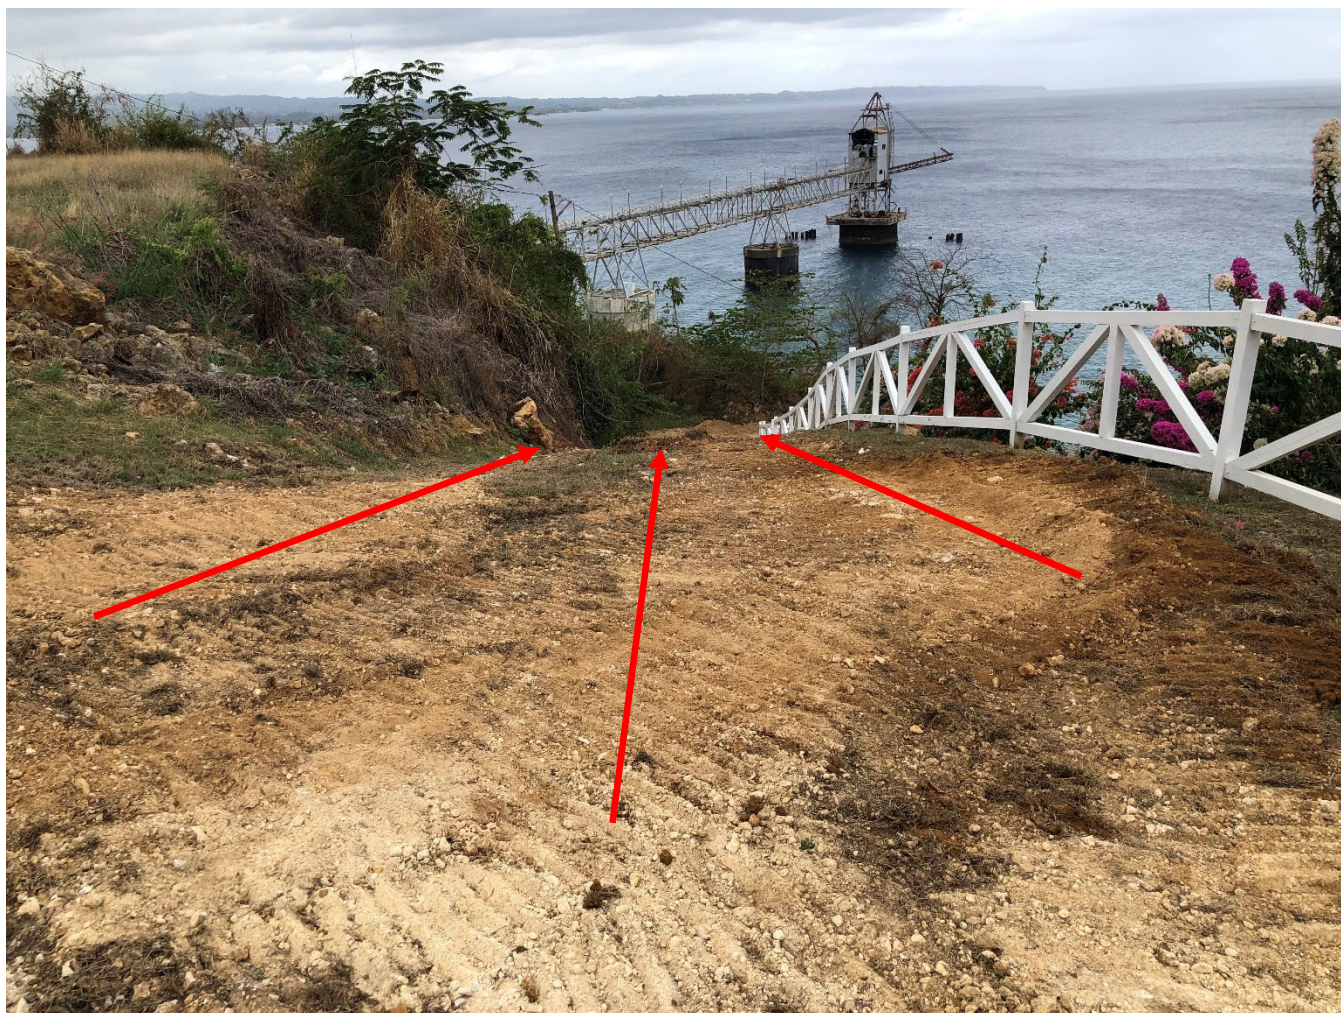
- ✚ This picture depicts a soil disturbed area (i.e., clearing and grubbing), which is an dirt road towards the shoreline area where conveyor pillars are found. This area was disturbed for access to the two structures (Gazebo and Potrero) on the lower west side of the Site.
- ✚ Erosion controls were not implemented.
- ✚ Fresh tracks of heavy equipment and loose soil also depicted.
- ✚ The red-colored arrows depict downhill runoff path.

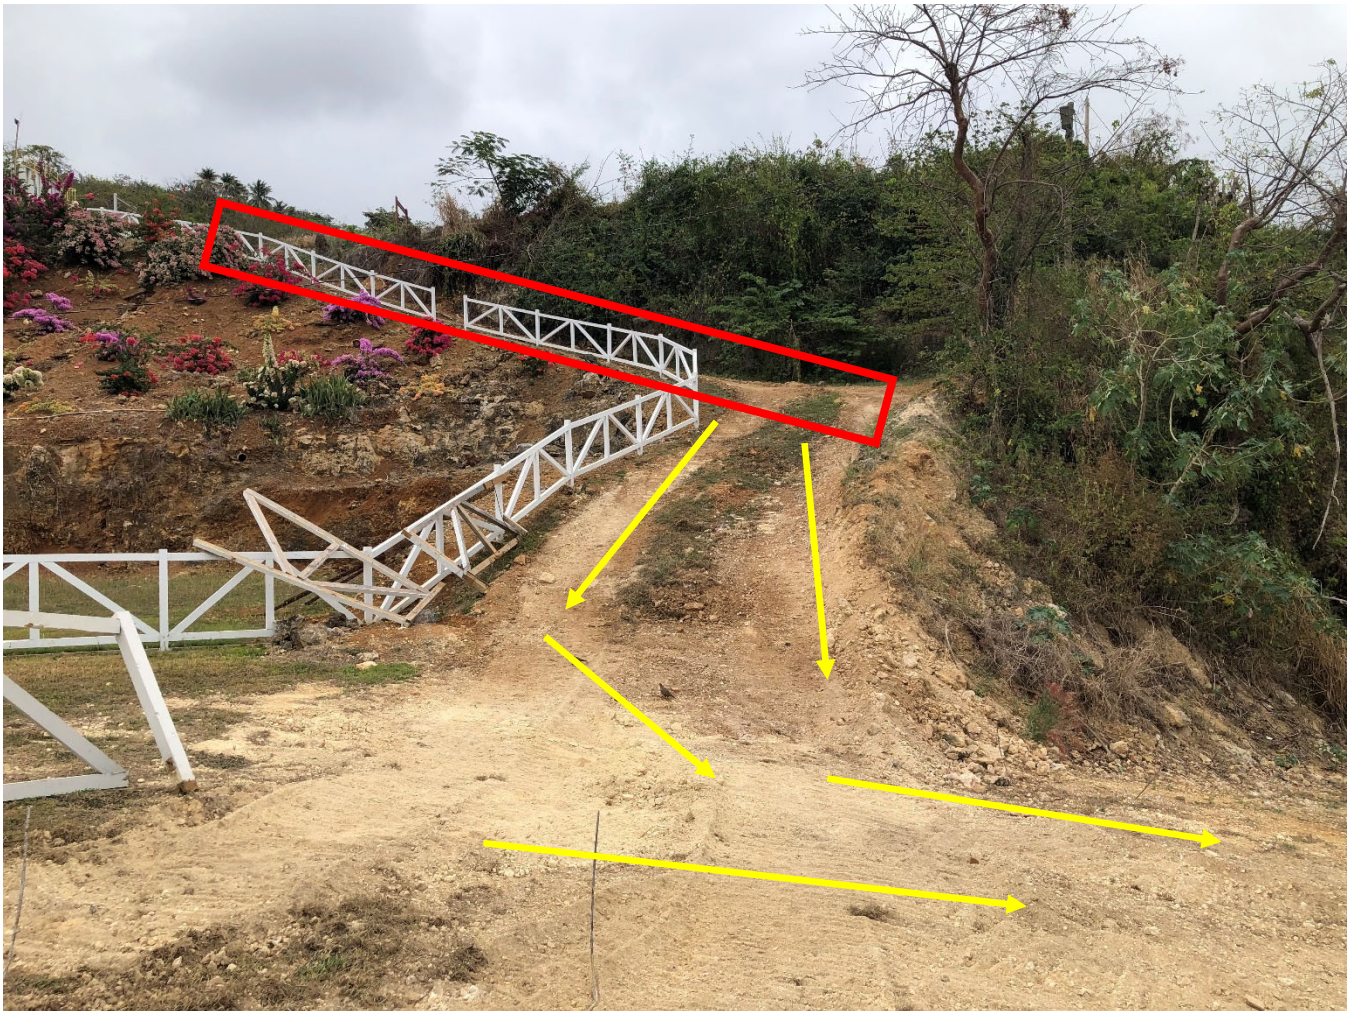
- ✚ This picture depicts another view of soil disturbed area (i.e., clearing and grubbing) shown on Picture 18 (above), which is a dirt road towards the shoreline area where the conveyor pillars are found. This area was disturbed for access to the two structures (Gazebo and Potrero) on the lower west side of the Site.
- ✚ Erosion controls were not implemented.
- ✚ Fresh tracks of heavy equipment and loose soil also depicted.
- ✚ The red-colored rectangle depicts a front view of the area shown on Picture 18 (above). The yellow-colored arrows depict the downhill runoff path towards the shoreline.

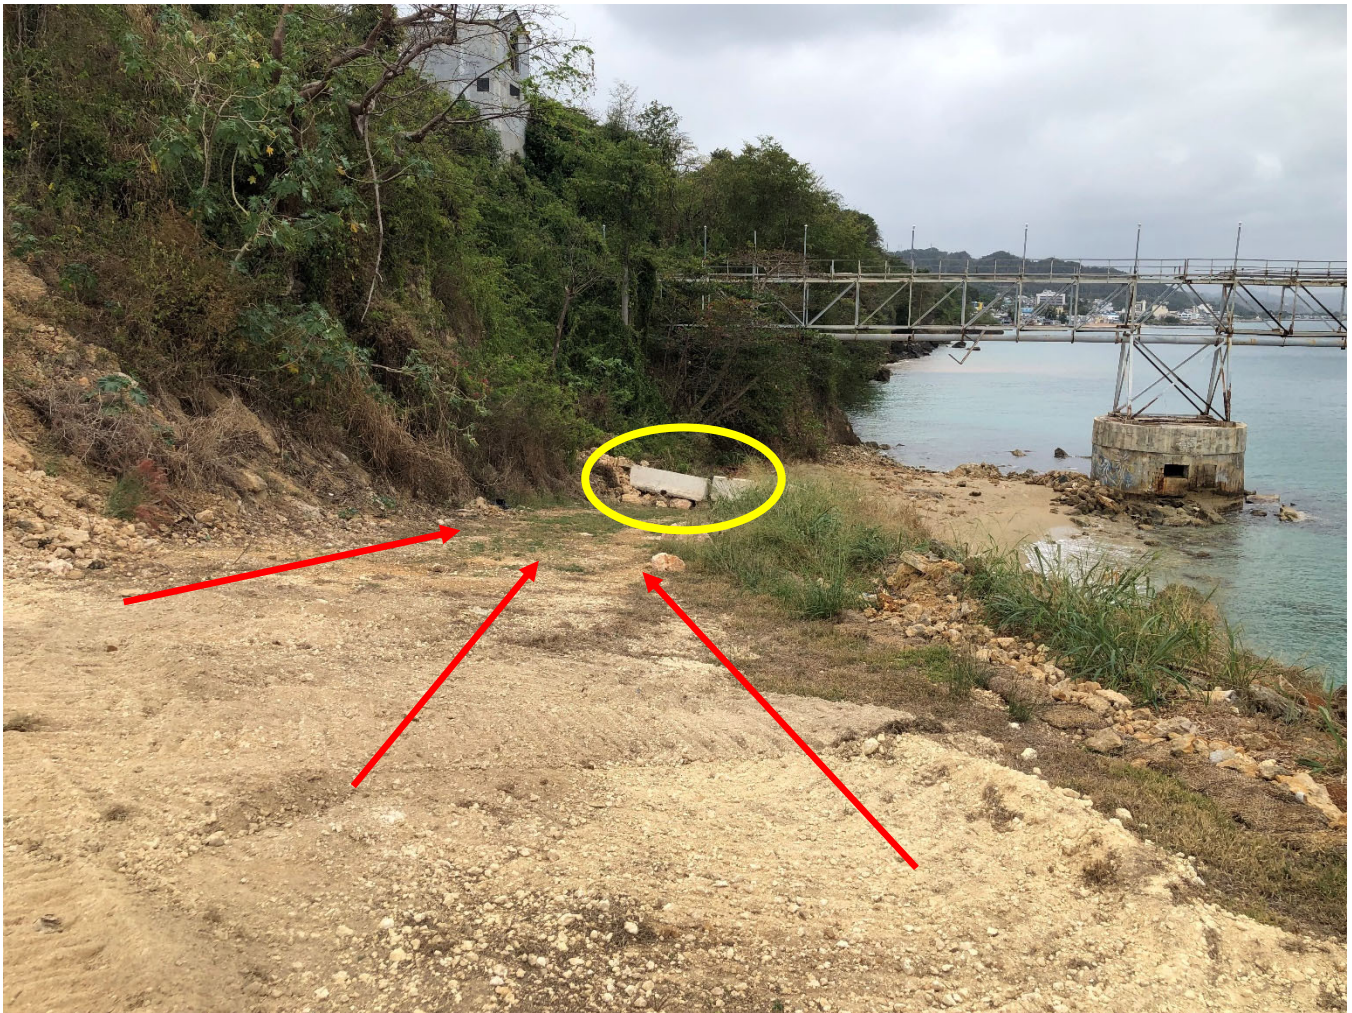
Picture 20
(Iphone 8+ Camara: IMG_5658.JPG; 2/23/23; 11:08 a.m.)

- ✚ This picture depicts the lower area of the dirt road to the shoreline where one of the conveyor pillows is located.
- ✚ The yellow-colored ellipse depicts an area of the access road blocked with boulders and concrete portable low walls, and an identified outfall during the Inspection, which has been named Outfall 004 for the purposes of this Inspection Report.
- ✚ The red-colored arrows depict downhill storm water runoff path towards the shoreline.

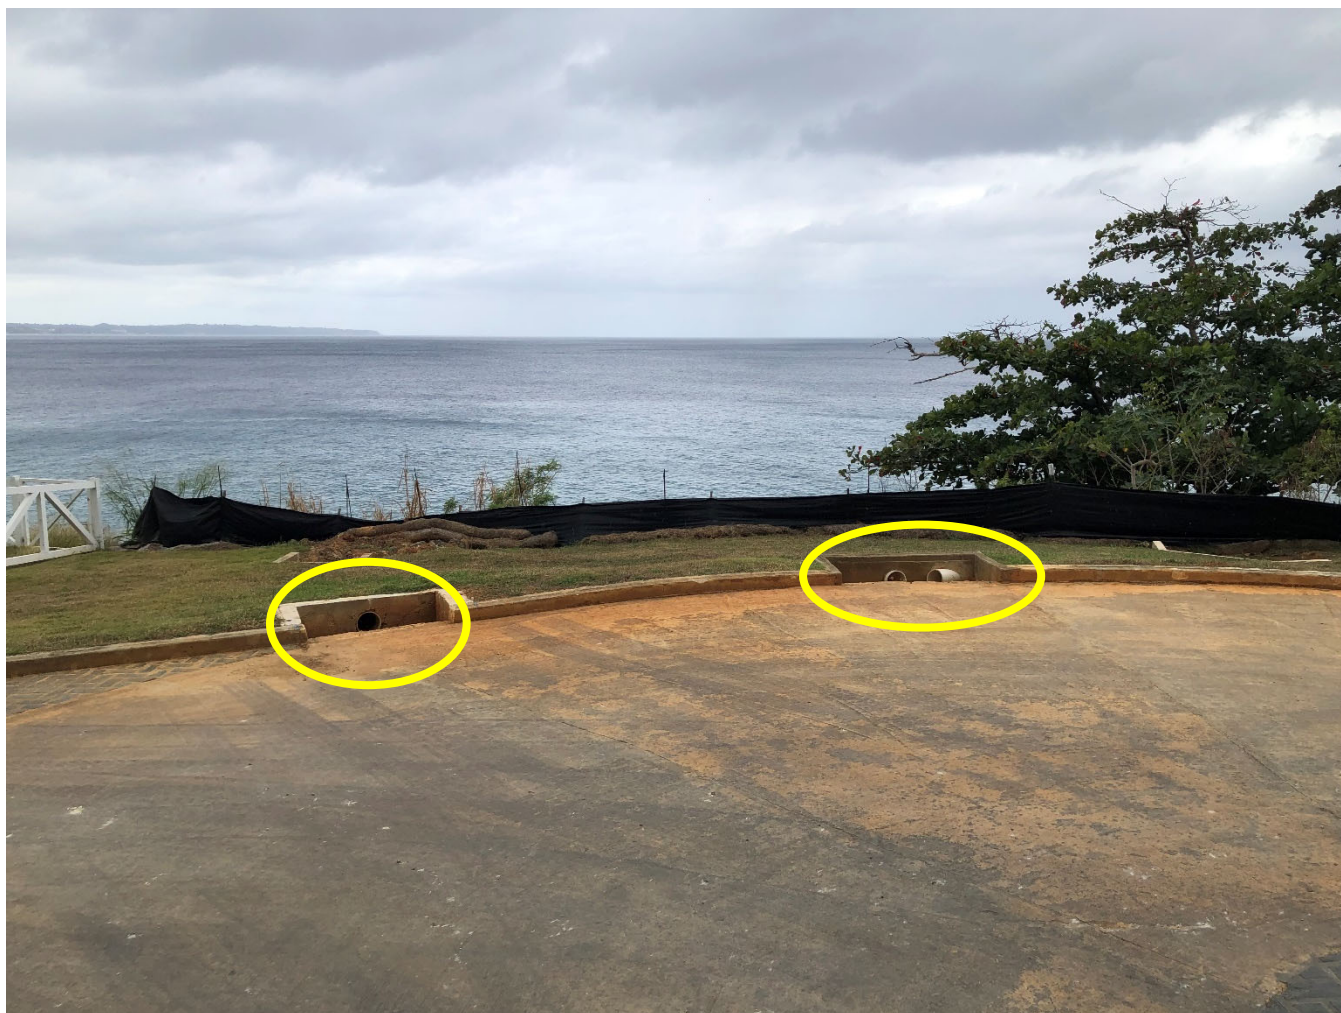
- ✚ This picture depicts the lower area of the access road to the areas where two structures (Gazebo and Potrero) were built (and demolished) on the west areas of the Site.
- ✚ The yellow-colored ellipses depict Outfall 003. The “Change NOI” indicates 003: Atlantic Ocean Rotonda.
- ✚ End of pipe flow dissipation installed, as depicted (i.e., silt fence, sod grass, and logs).

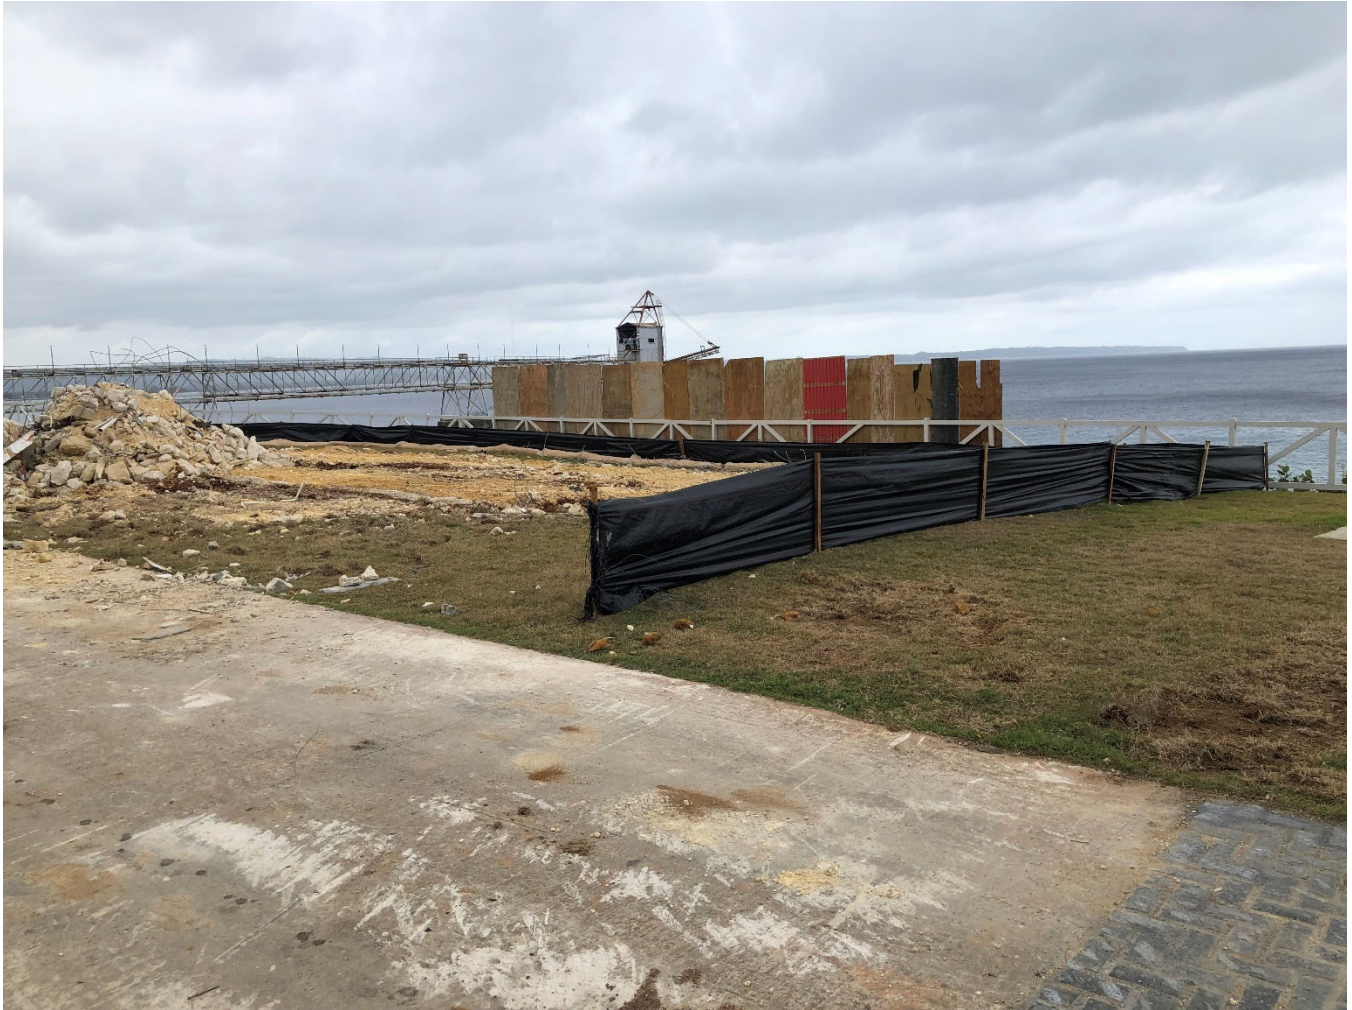
Picture 22
(Iphone 8+ Camara: IMG_5656.JPG; 2/23/23; 11:05 a.m.)

- ✚ This picture depicts an area on the lower west side of the Site where a pile containing soil, concrete pieces, and bars, among other materials, are found.
- ✚ This is the areas where the Gazebo was constructed and then, demolished.
- ✚ Silt fence was installed along the perimeter of the area where the Gazebo was located.

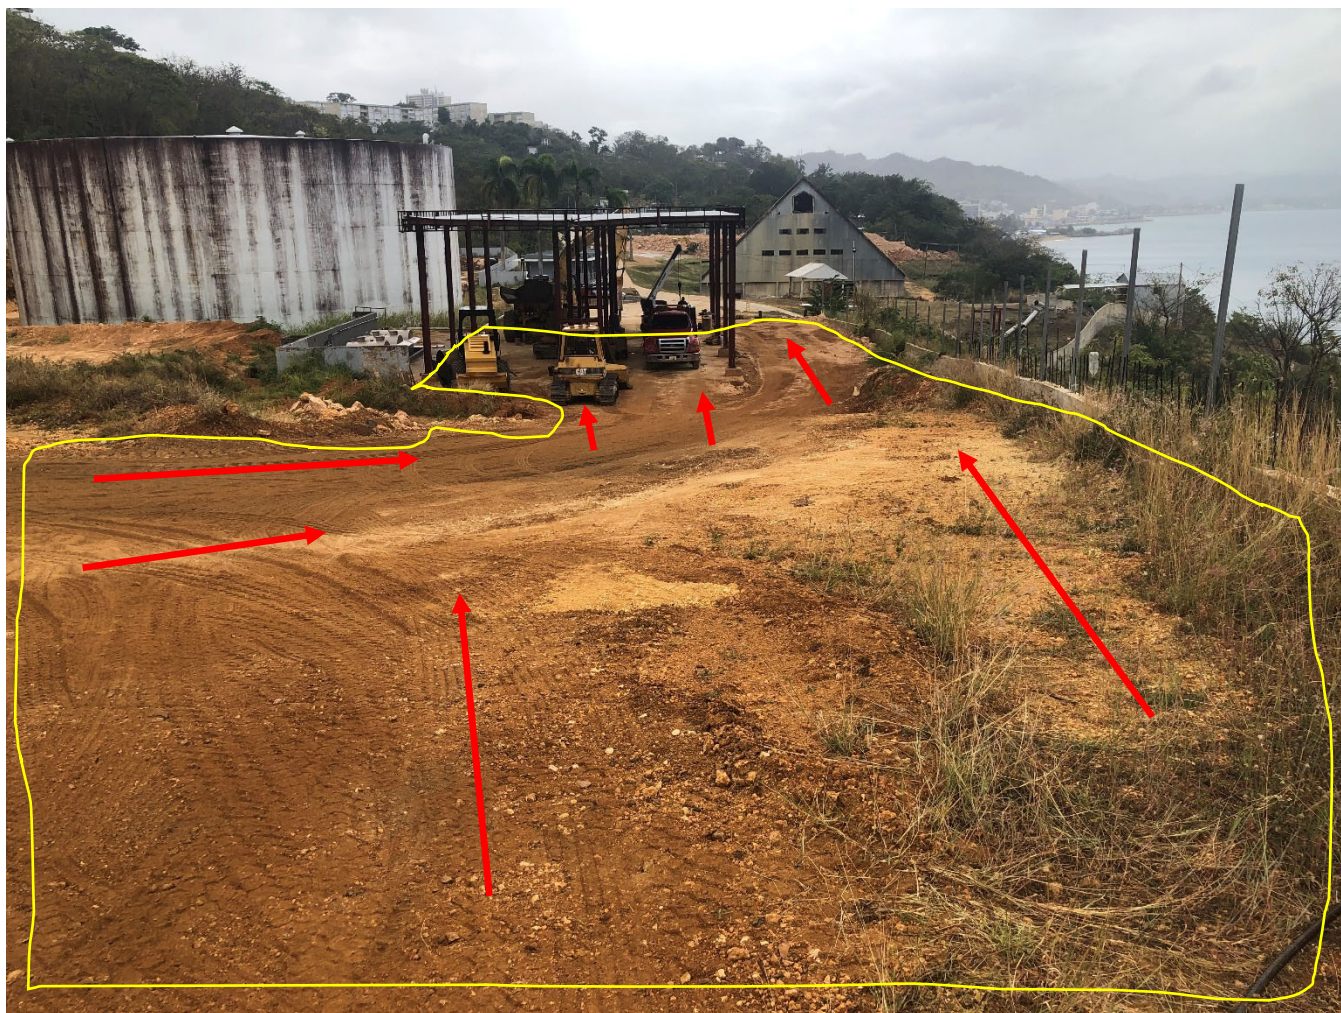
- ✚ This picture depicts a wider view of the Site, which was taken from the northwest area. It depicts, among others, the northside of the Warehouse Building, Mechanical Shop Structure, above-ground storage tank, and disturbed soils on the upper north areas.
- ✚ The red-colored arrows depict the storm water flow path towards the lower mid area of the Site. The Mechanical Shop Building does not have any best management practice (e.g., low concrete wall) along its north, west, and south sides, to prevent and manage runoff from flowing through it.
- ✚ Picture also depicts fresh track marks on the disturbed soils.
- ✚ No erosion controls implemented to address the flow in yellow-colored areas shown in this picture.

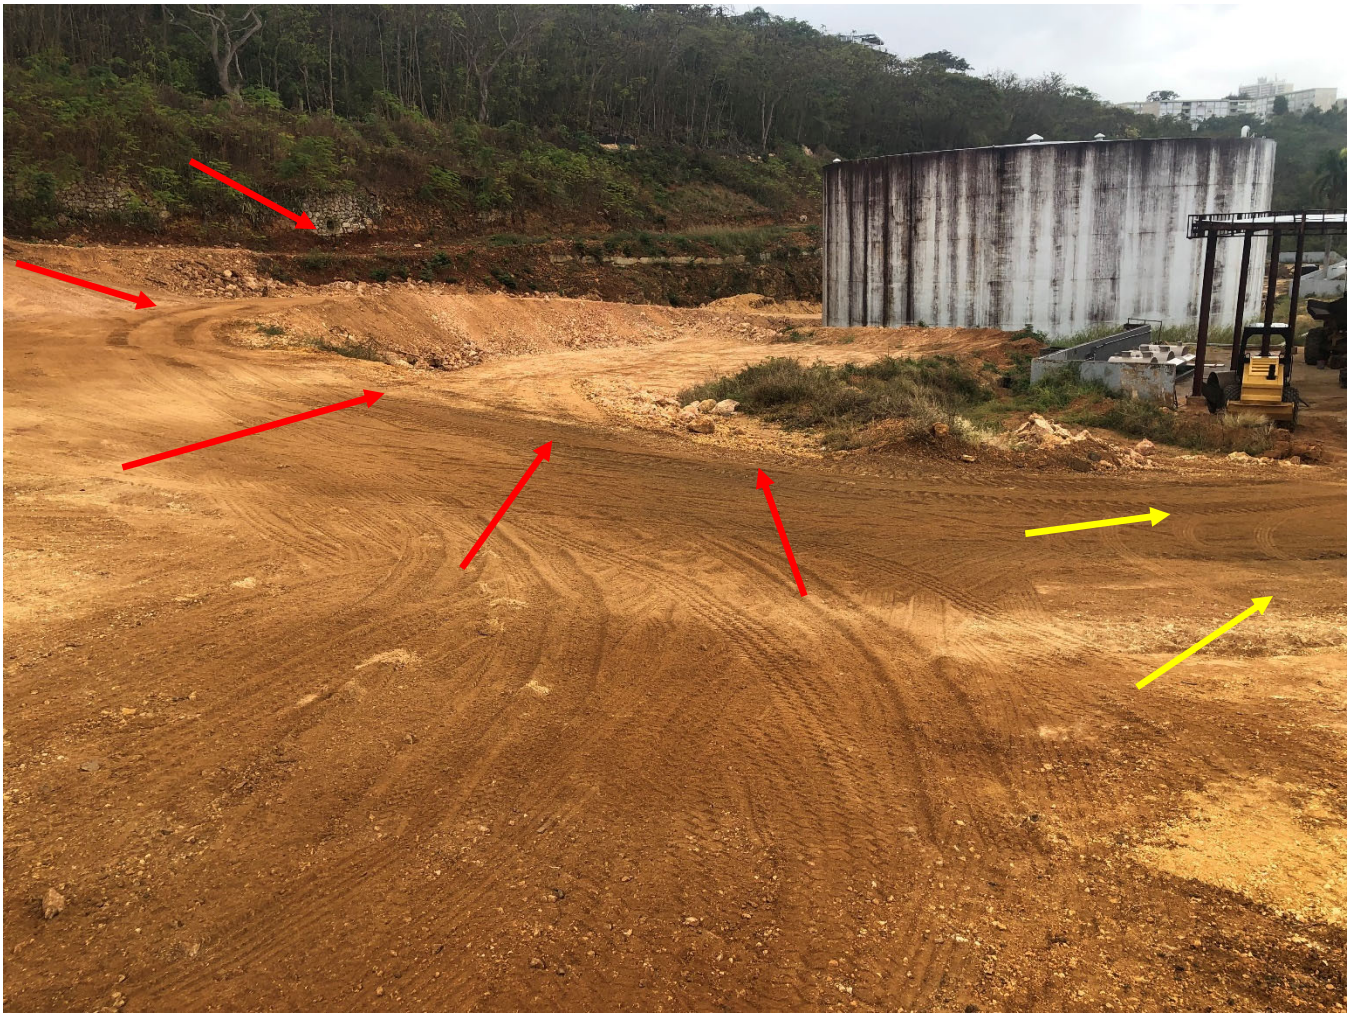
Picture 24
(Iphone 8+ Camara: IMG_5662.JPG; 2/23/23; 11:19 a.m.)

- ✚ This picture depicts an upper side area of the Site, just north of the Mechanical Shop Structure and the above-ground storage tank, in which disturbed soil and fresh tracks on the ground shown.
- ✚ The red-colored arrows depict the approximate storm water runoff path towards a temporary storm water retention pond, which overflows toward a larger area that has a concrete retaining wall on the west and south side that creates an impoundment area.
- ✚ The yellow-colored arrows depict the approximate storm water runoff path towards areas within the Mechanical Shop Structure and beyond.

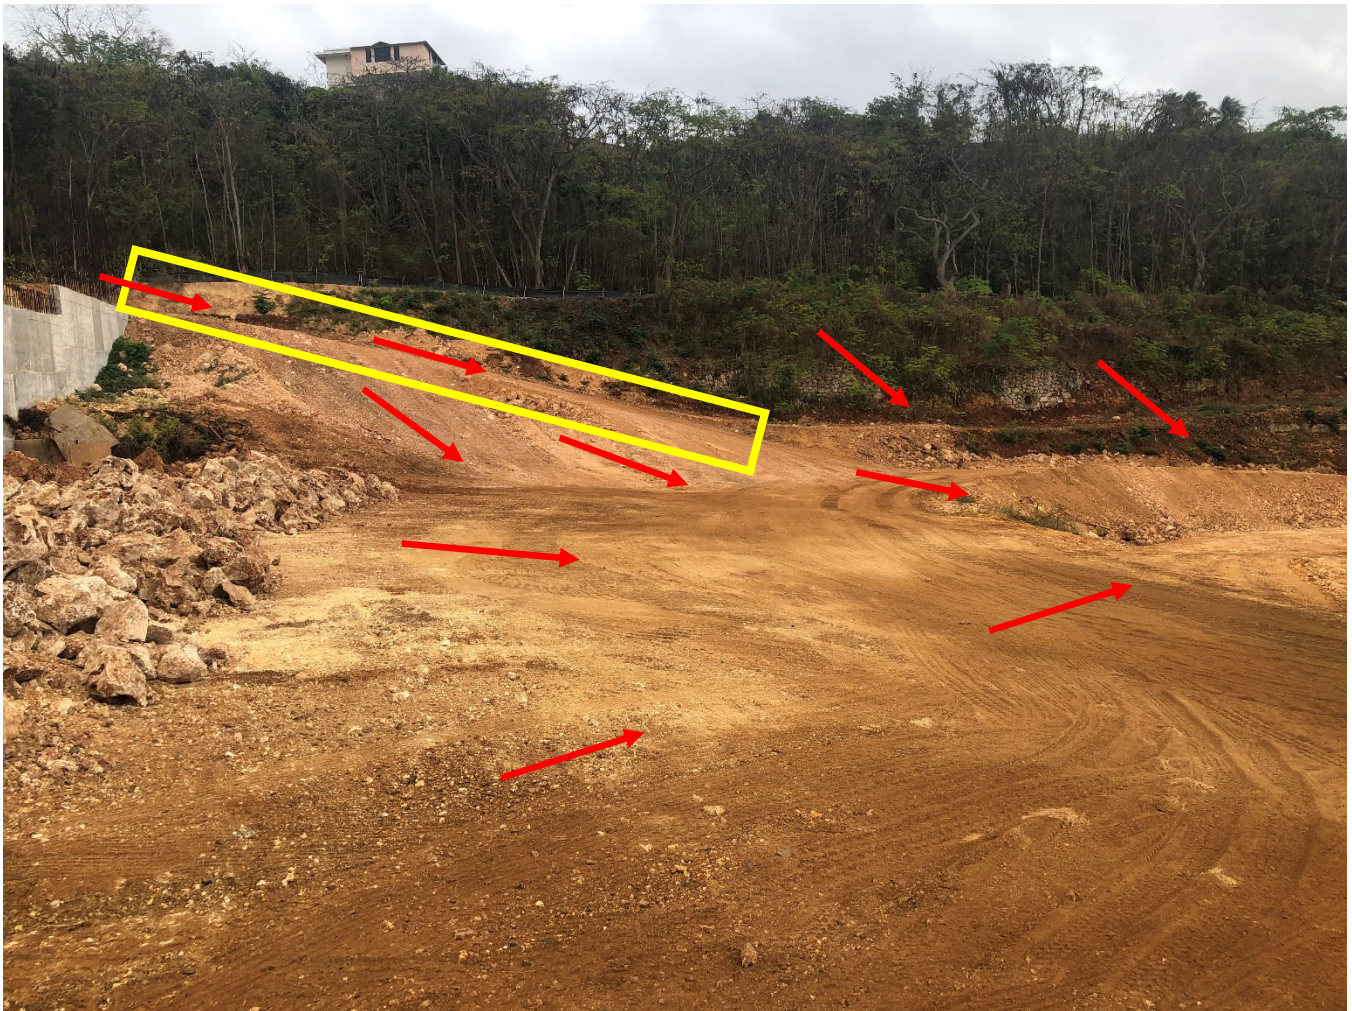
Picture 25
(Iphone 8+ Camara: IMG_5661.JPG; 2/23/23; 11:19 a.m.)

Based on the observations made during the walkthrough of the Site and documented in **Attachment 4** of this Inspection Report, the access road on the upper northwest area of the Site was blocked and closed. On the other hand, the other access road on the upper northeast area of the Site was found opened and per with Mr. Nieves statements, it has been used for access between the Site and the The Cliff site.

- ✚ This picture depicts the access area between the Site and the The Cliff located on the northeast area of the Site, which is demarked with the yellow-colored rectangle.
- ✚ The red-colored arrows depict the approximate runoff path towards a temporary retention pond and the impoundment area described in Picture 24 (above).
- ✚ This access area is one of other storm water run-on locations into the Site, which does not have any run-on control measures to divert from exposed soils.

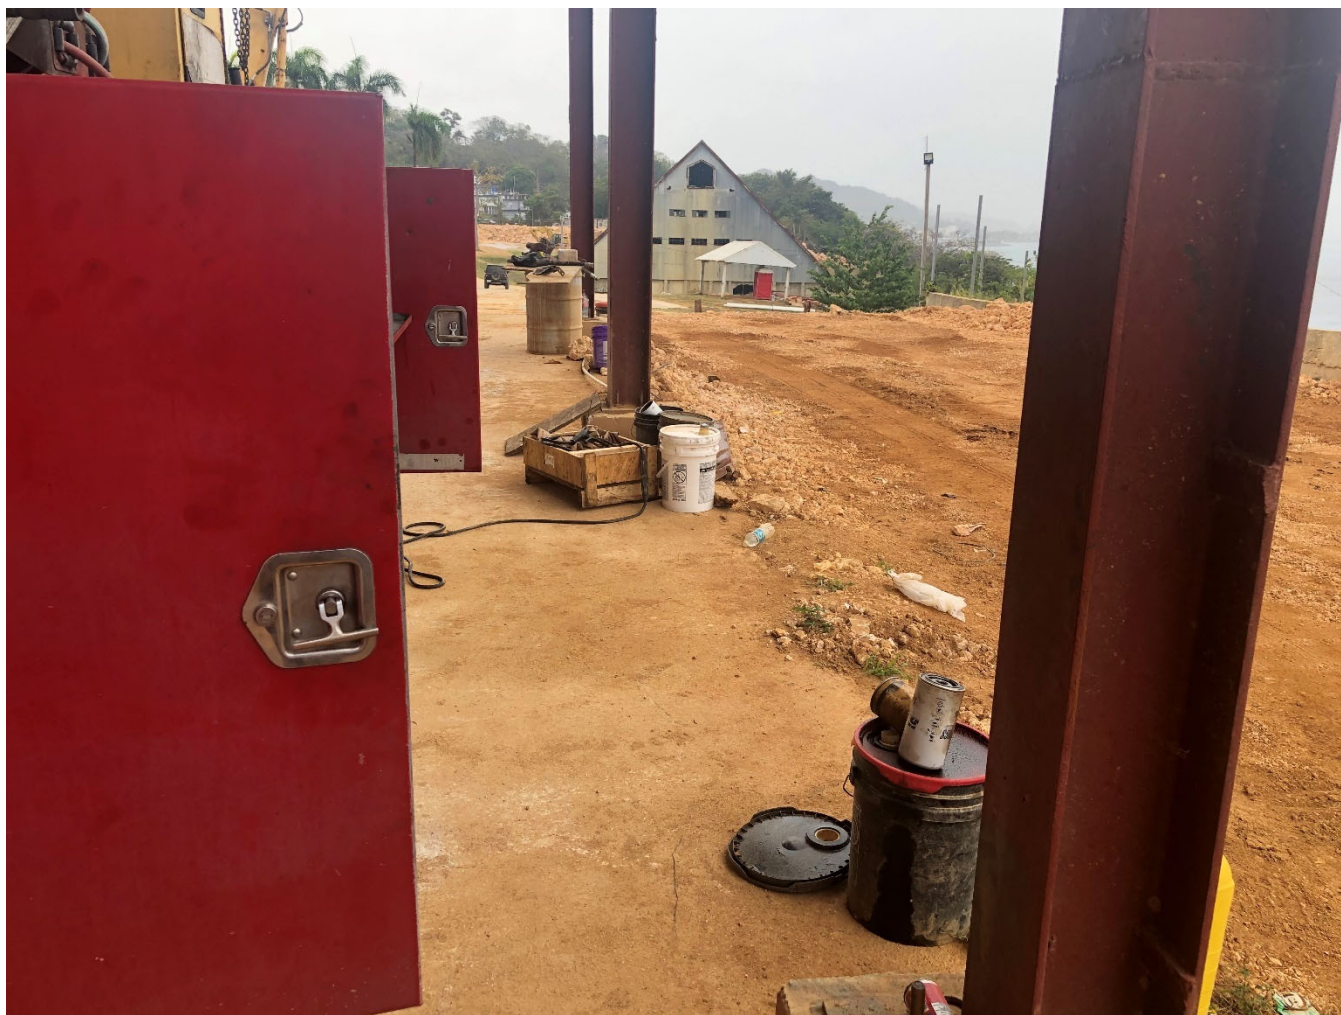
- ✚ This picture depicts the west side of the Mechanical Shop Structure lacking storm water management to divert and eliminate runoff from entering into the concrete slab and getting in contact with the activities and materials therein.
- ✚ This picture also depicts used oil filter exposed to rain and other containers without any pollution prevention measures.

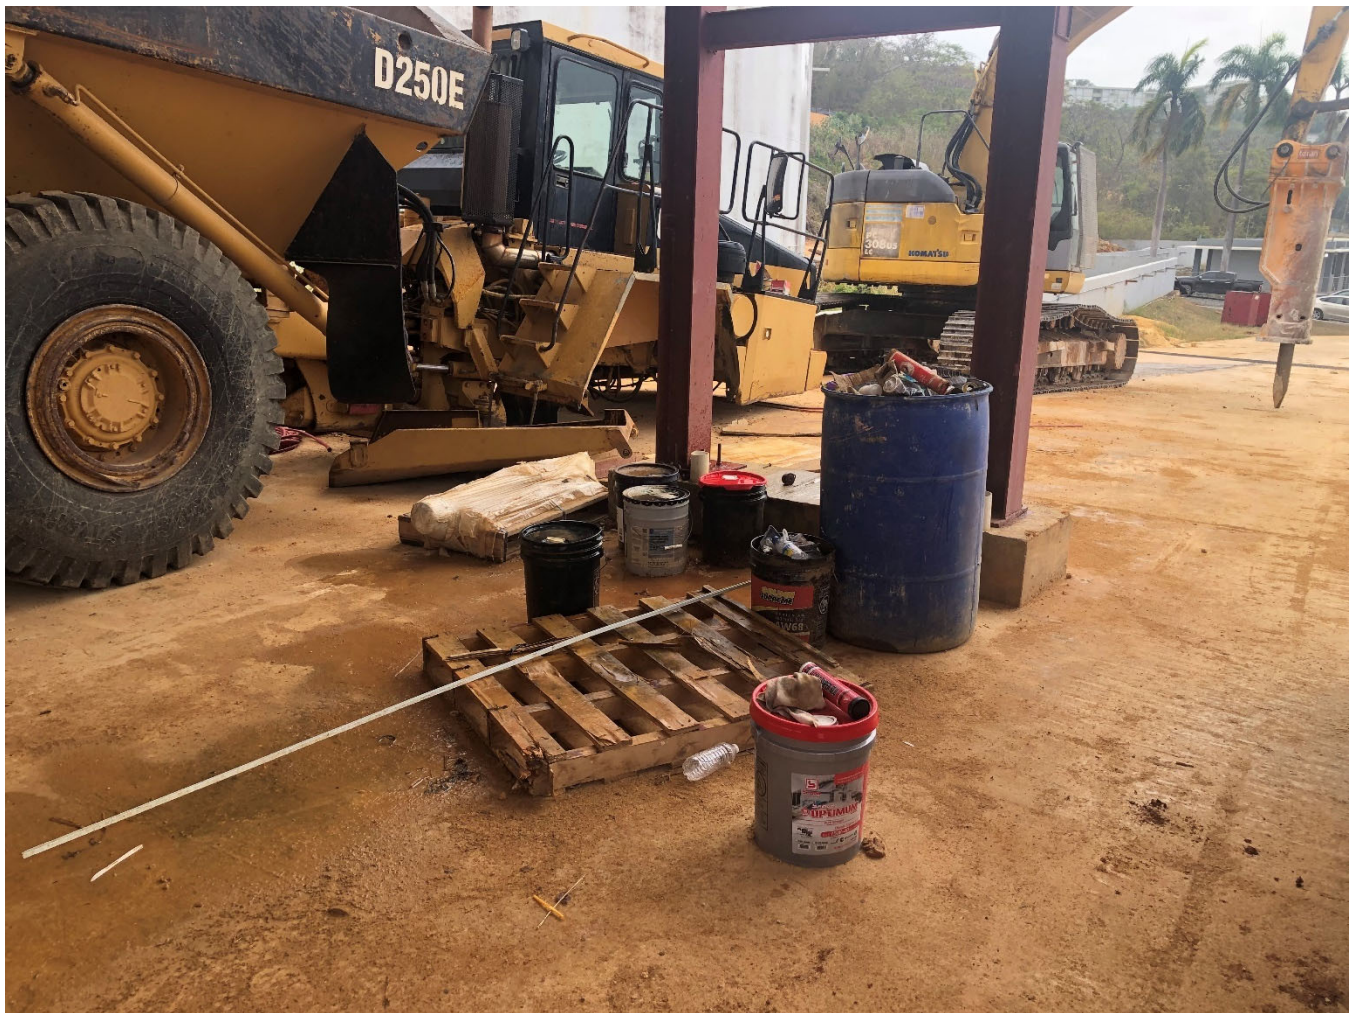
Picture 27
(Iphone 8+ Camara: IMG_5664.JPG; 2/23/23; 11:39 a.m.)

- ✚ This picture depicts an area inside the Mechanical Shop Building.
- ✚ I observed individuals performing repairs to machinery.
- ✚ I also observed opened containers and oil stains on the concrete floor, and lack of pollution prevention controls therein.
- ✚ A 55-gallon blue-colored container had trash and other waste without cover.
- ✚ Sediment track towards the slope beyond the south side of the Mechanical Shop Structure was also observed, which is also shown in this picture.

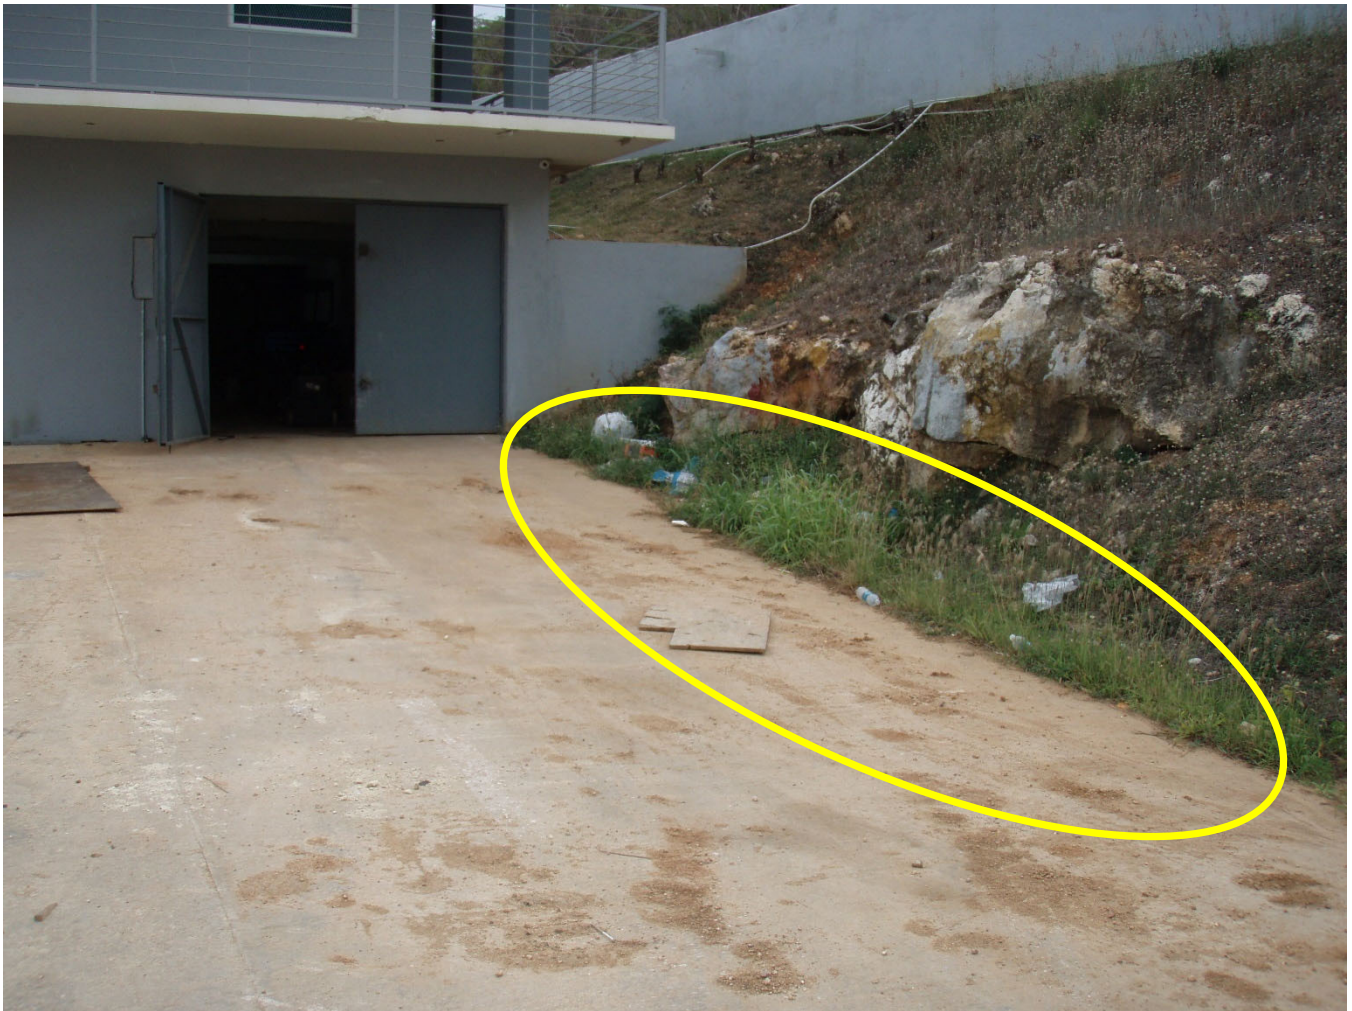
Picture 28
(Nikon Camara: P2221335.JPG; 2/23/23; 10:30 a.m.)

- ✚ Litter and trash shown in yellow-colored ellipse located south of the Administrative Office.
